# INSTALLATION RESTORATION PROGRAM

## Records Search

169th Tactical Fighter Group  
South Carolina Air National Guard  
McEntire Air National Guard Base

Hazardous Materials Technical Center  
January 1984

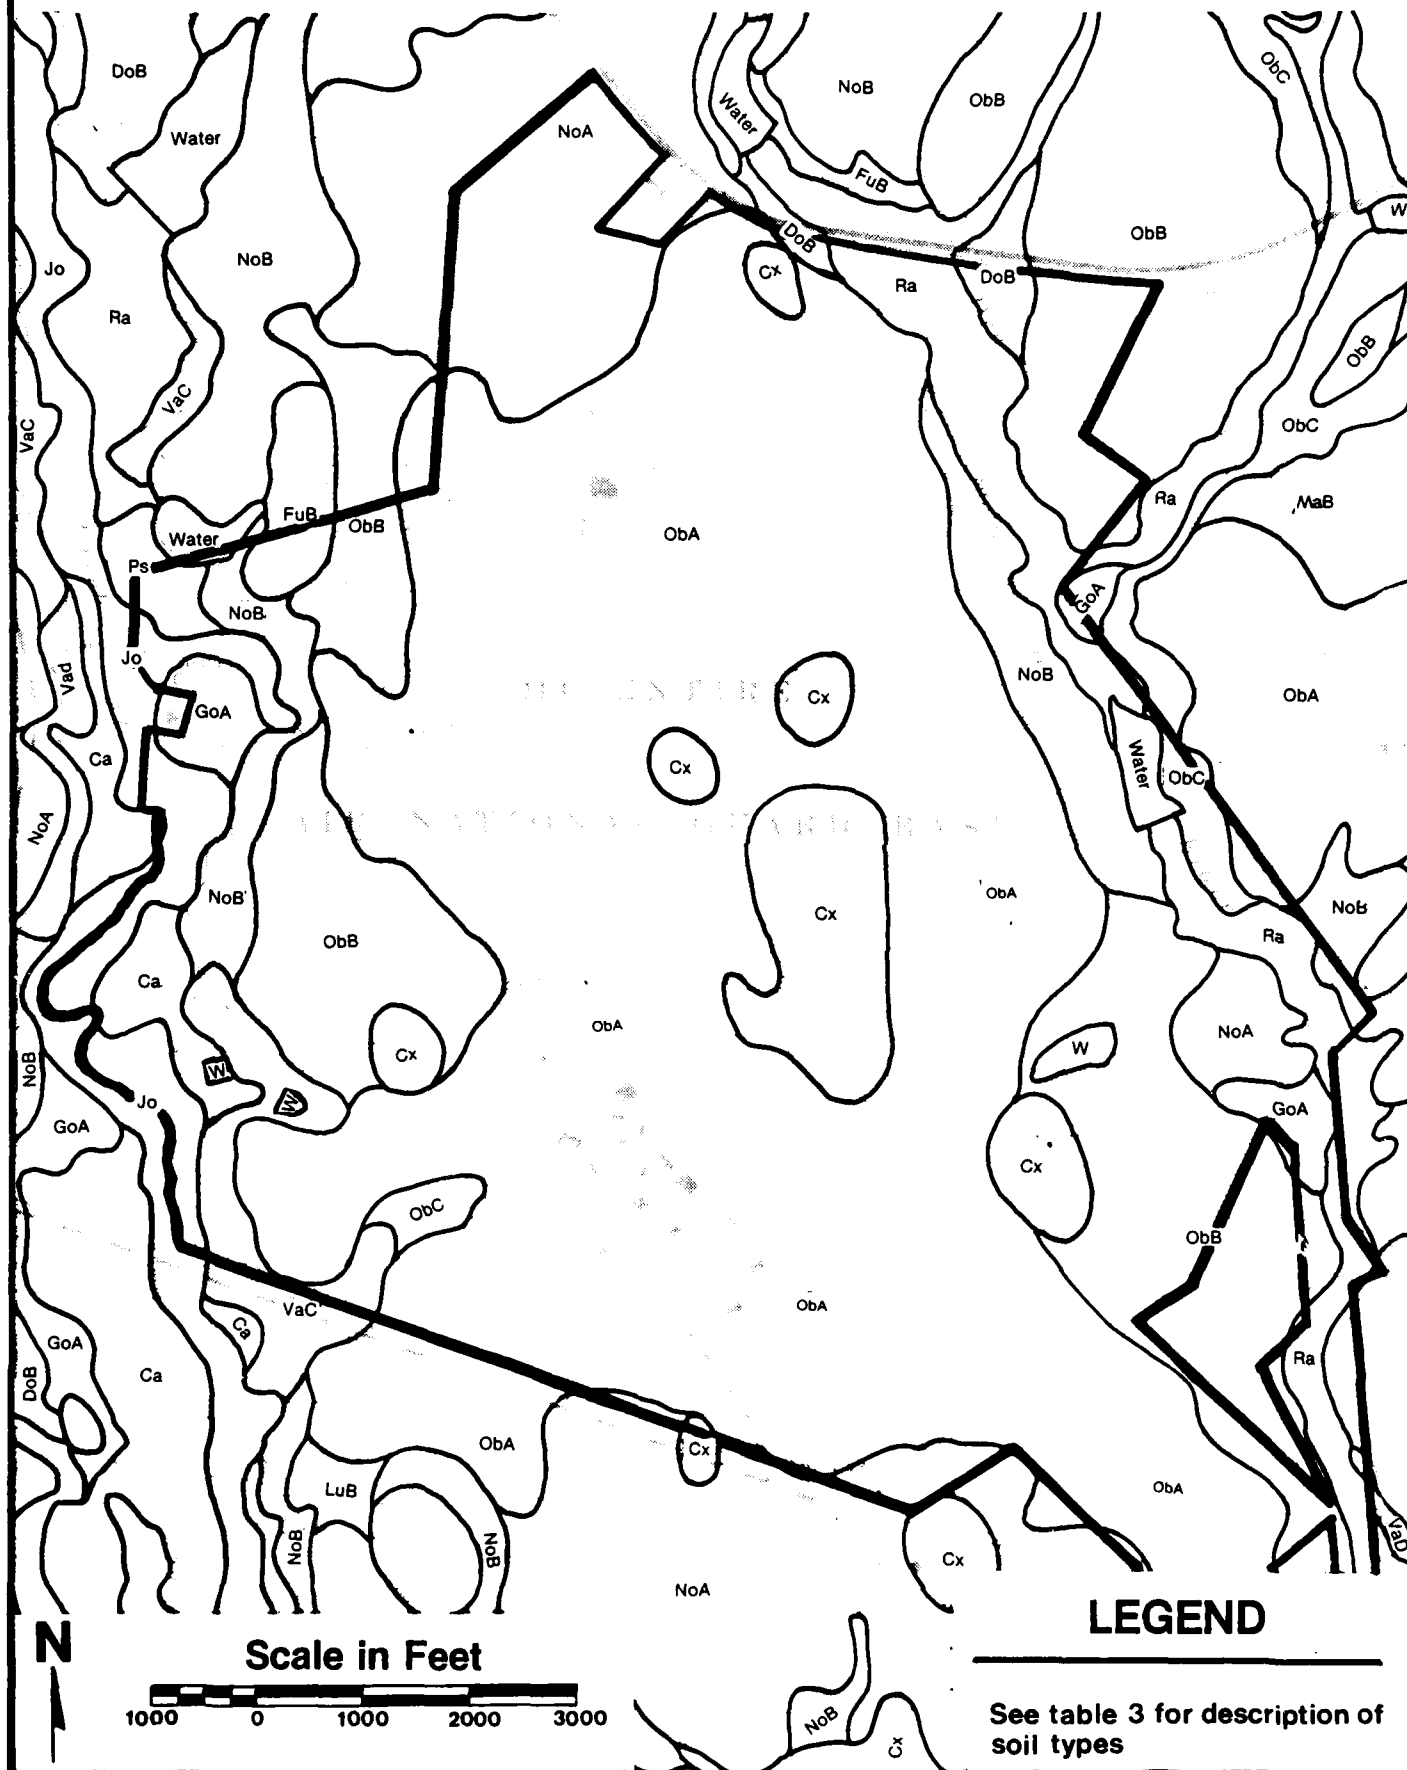
**FIGURE 7.**  
Map of Soils at McEntire ANGB.

Figure 7 illustrates the locations of these and other soils present on or near McEntire ANG Base. Table 3 summarizes important physical and chemical properties of these soils such as permeability, potential for erosion, and hydrologic classification. Permeability is estimated on the basis of known relationships among the soil characteristics observed in the field--particularly soil structure, porosity, and gradation or texture--that influence the downward movement of water in the soil. The estimates are for vertical water movement when the soil is saturated. Not considered in the estimates is lateral seepage or such transient soil features as plowpans and surface crusts. Erosion factors are used to predict the erodibility of a
